Ten years of recycled water use at Big Canyon Country Club, Newport Beach, California ¹PACE Turfgrass Research Institute, San Diego, CA; ²Big Canyon Country Club, Newport Beach, CA Larry Stowell¹, Wendy Gelernter¹ and Jeff Beardsley²

Summary

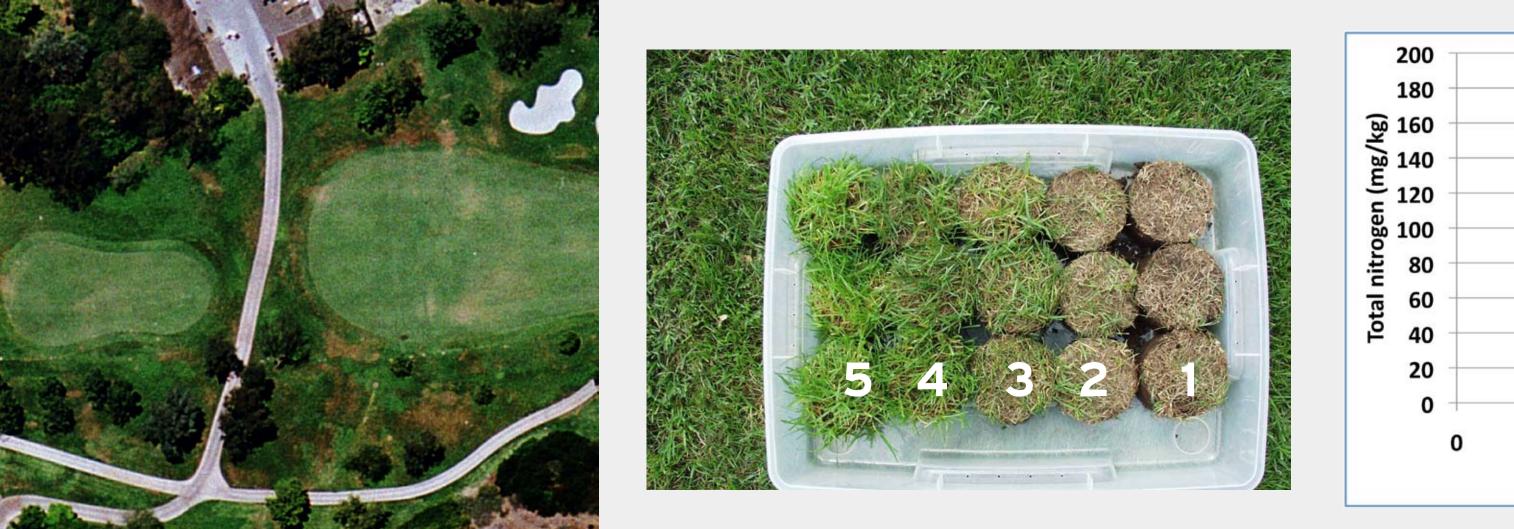
Figure 3. Turf damage due to high soil nitrogen levels. Damage to ryegrass roughs (lower left) was investigated by analyzing soil samples that varied in quality from 1 (dead turf) to 5 (moderate quality). There was a strong negative correlation between turf quality and soil nitrogen, with the highest quality turf exhibiting the lowest (<20 mg/kg) N levels, and the lowest quality turf exhibiting the highest (>140 mg/kg) N levels.
